## **Limited Visual Dam Safety Inspection Summary Report**

**HI - 00122**

**Waikoloa 50 MG Reservoir 2**

**May 2006**

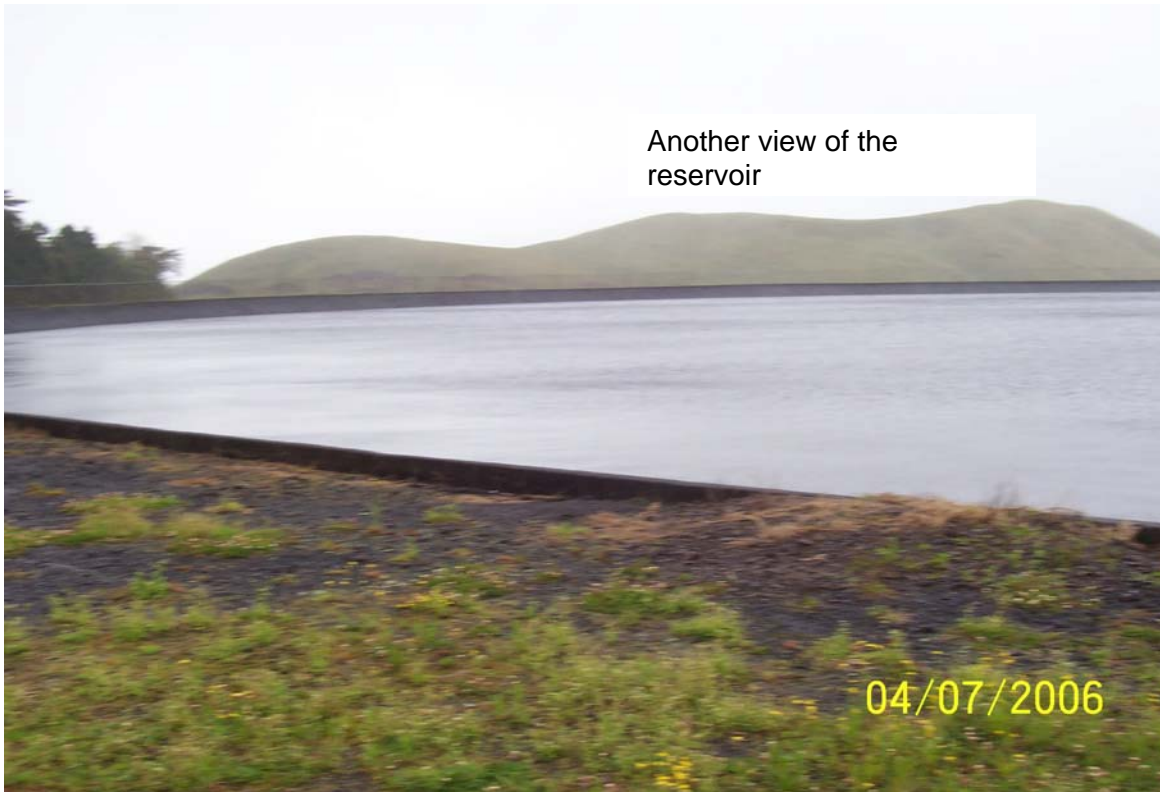
Another view of the reservoir

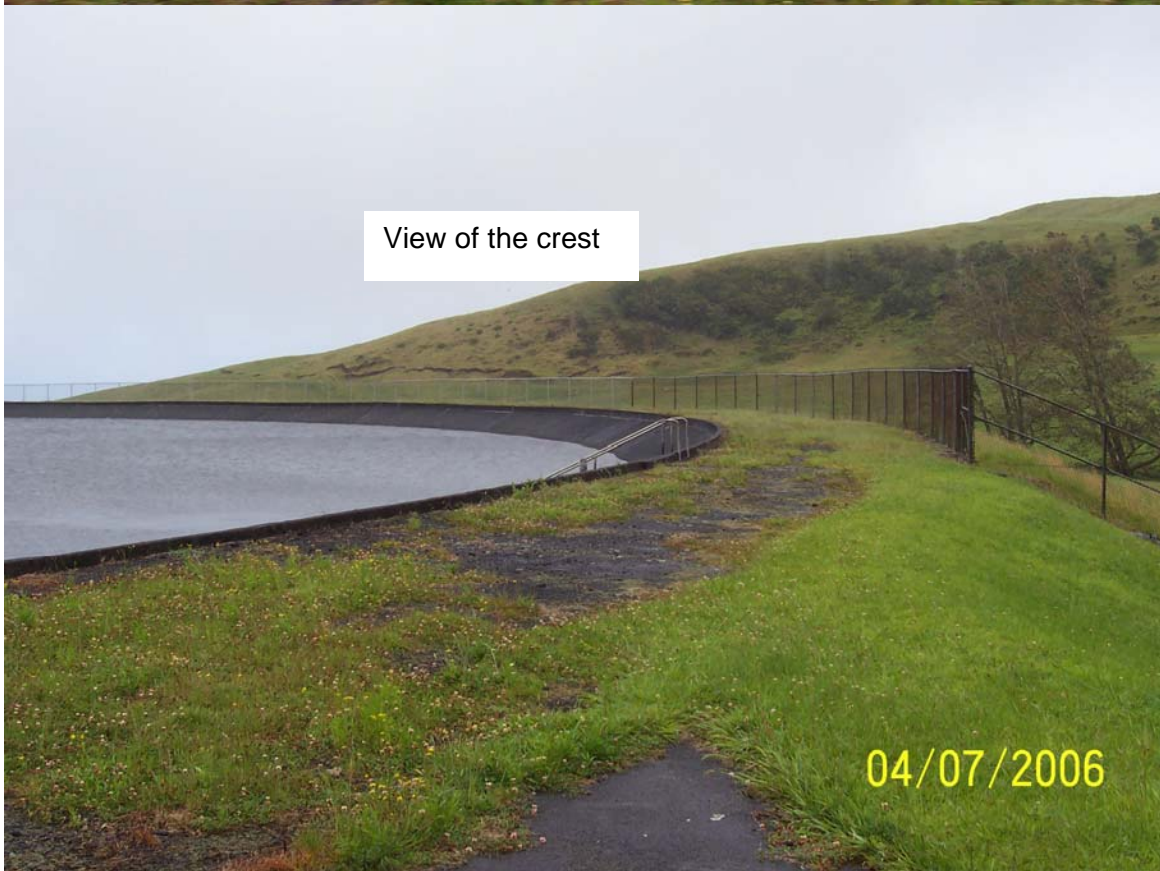
The dam crest was approximately 15 feet wide. There was an AC surfaced access road on top of the crest, which has grass growing through it. Minor erosion was observed, limited primarily to tire ruts. Vegetation was observed on the downstream shoulder of the crest. These were primarily high grass.

View of the crest

- a. The dam crest appeared to be in satisfactory condition, no corrective actions are required at this time.

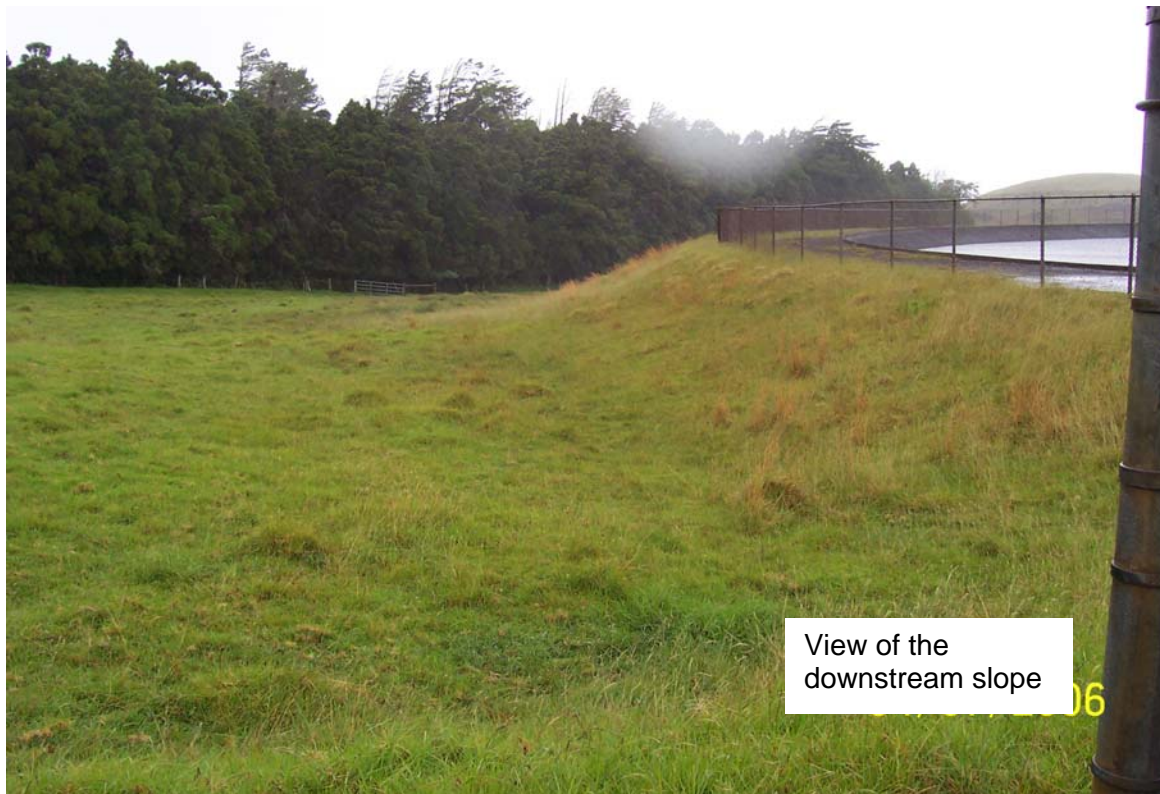
The downstream slope was in fair condition and not visible due to heavy vegetation. The slope was around a 1V to 2H slope. There was partial access to the downstream. There was no slope protection observed on the downstream slope. Erosion was not observed on the downstream slope, however the slope was not entirely visible. Sinkholes were not observed on the downstream slope, however the slope was not entirely visible. Vegetation was observed on the downstream slope. The majority of the vegetation was woody trees ranging from 8" to 2 feet in diameter. Seepage was not observed on the downstream toe, however the slope was not entirely visible.

View of the  
downstream slope

- a. The downstream slope was not inspected.
- b. The downstream slope appeared to be in fair to poor condition and requires corrective action.
- c. The down stream slope was not visible due to high grass and bush vegetation. Clear high vegetation and maintain low to enable easy visual inspection.
- d. Seepage/Ponding water was observed. Monitor and conduct further investigation to locate the source of water and extent of any possible hazardous or developing condition.

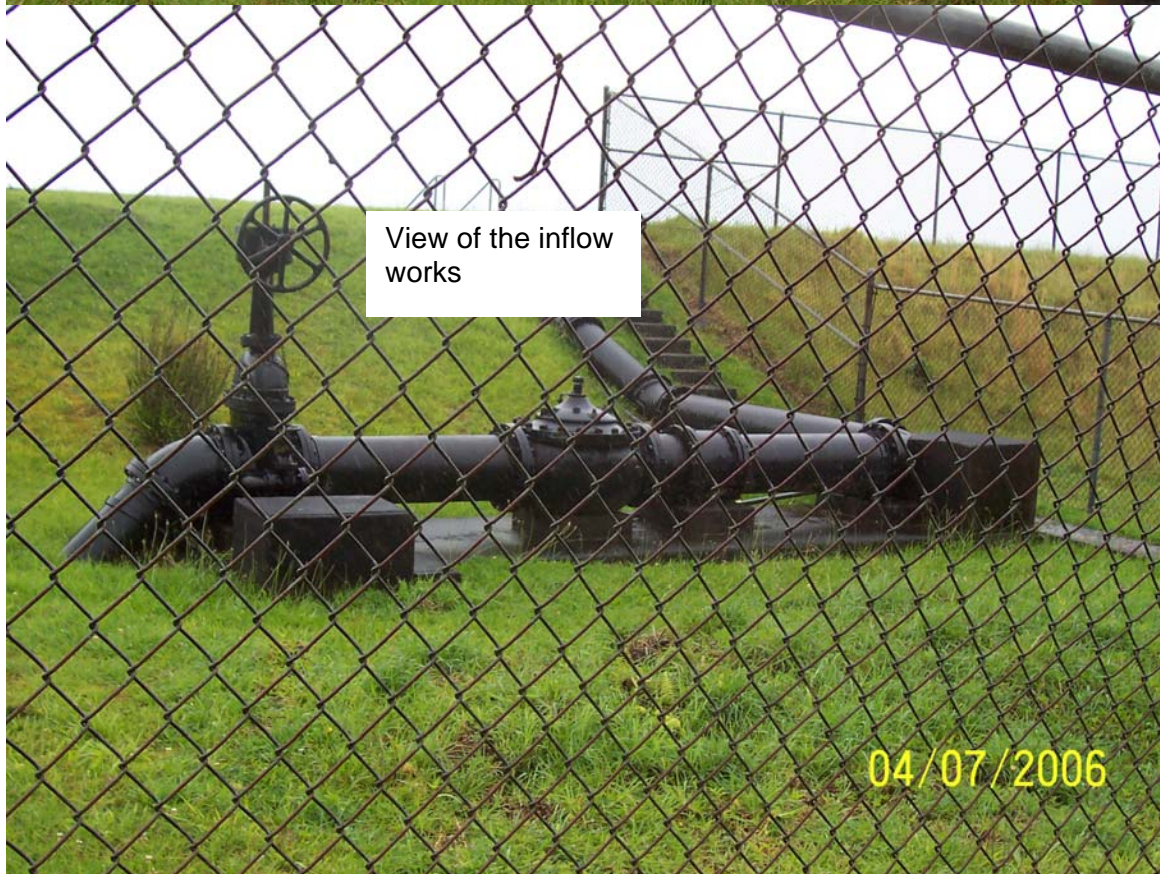
View of the inflow  
works

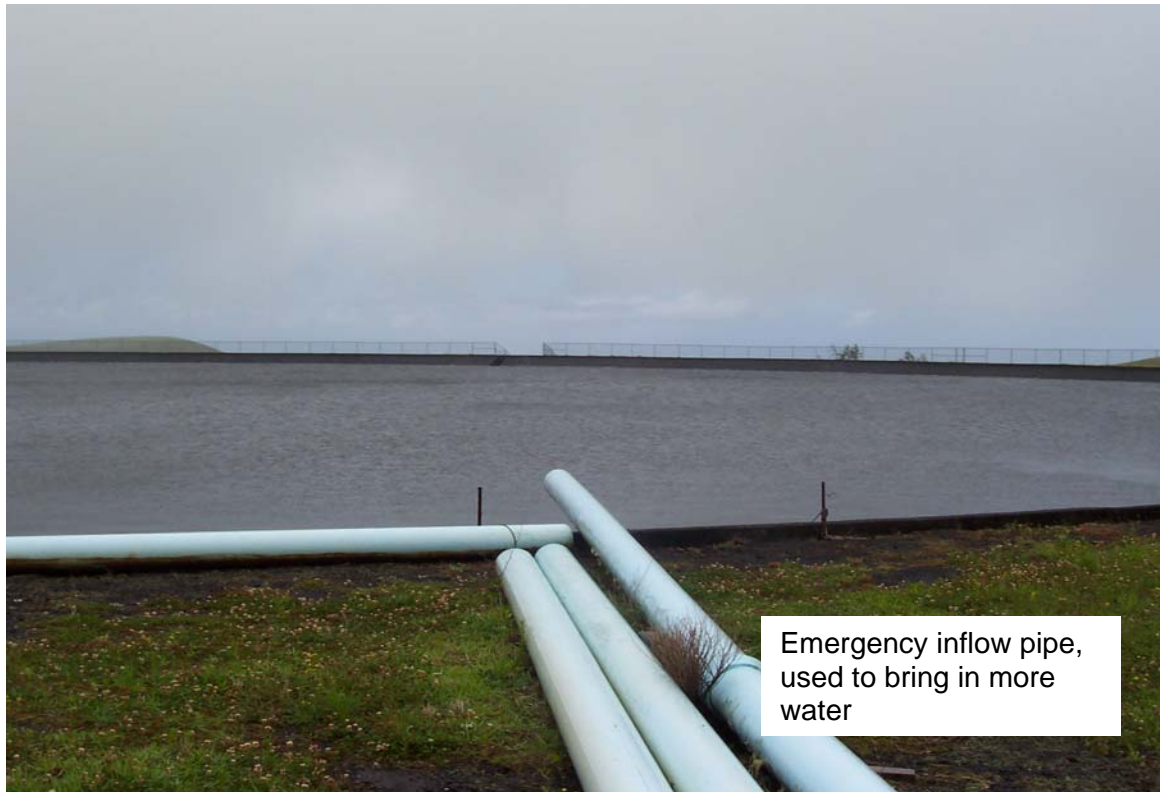
Emergency inflow pipe,  
used to bring in more  
water

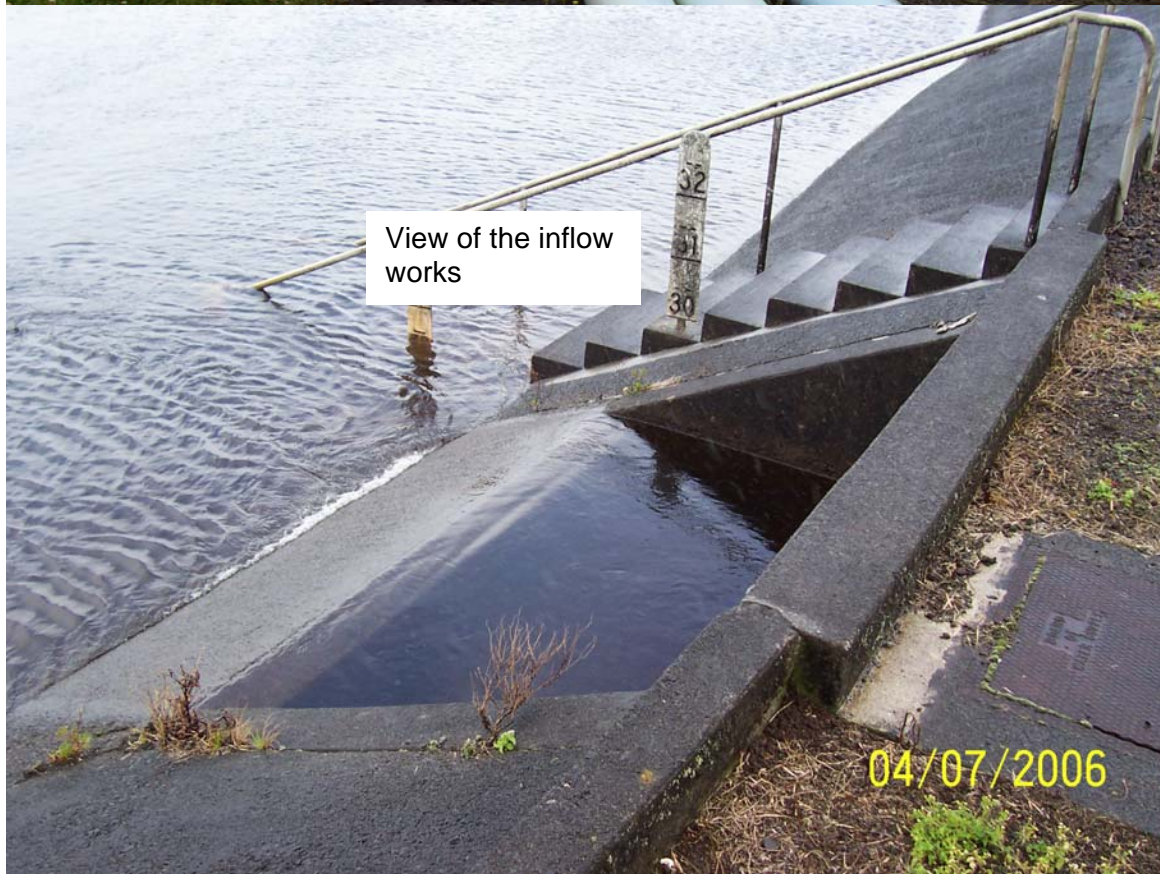
View of the inflow  
works

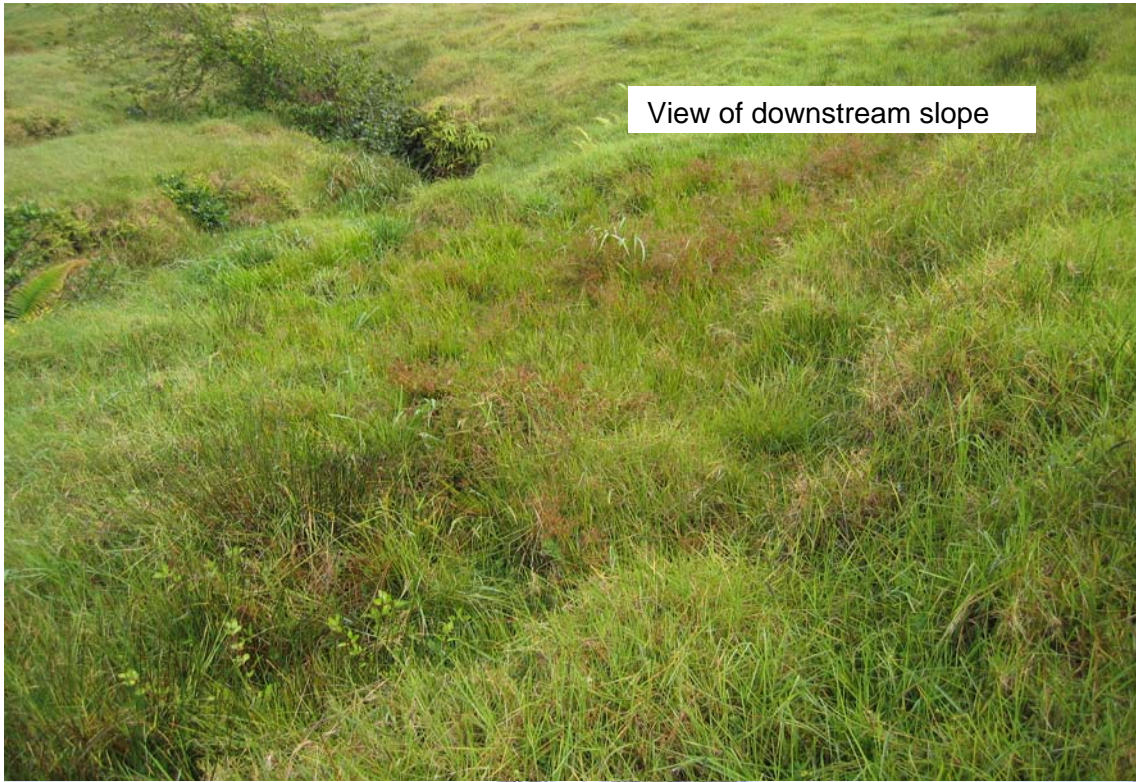
View of downstream slope

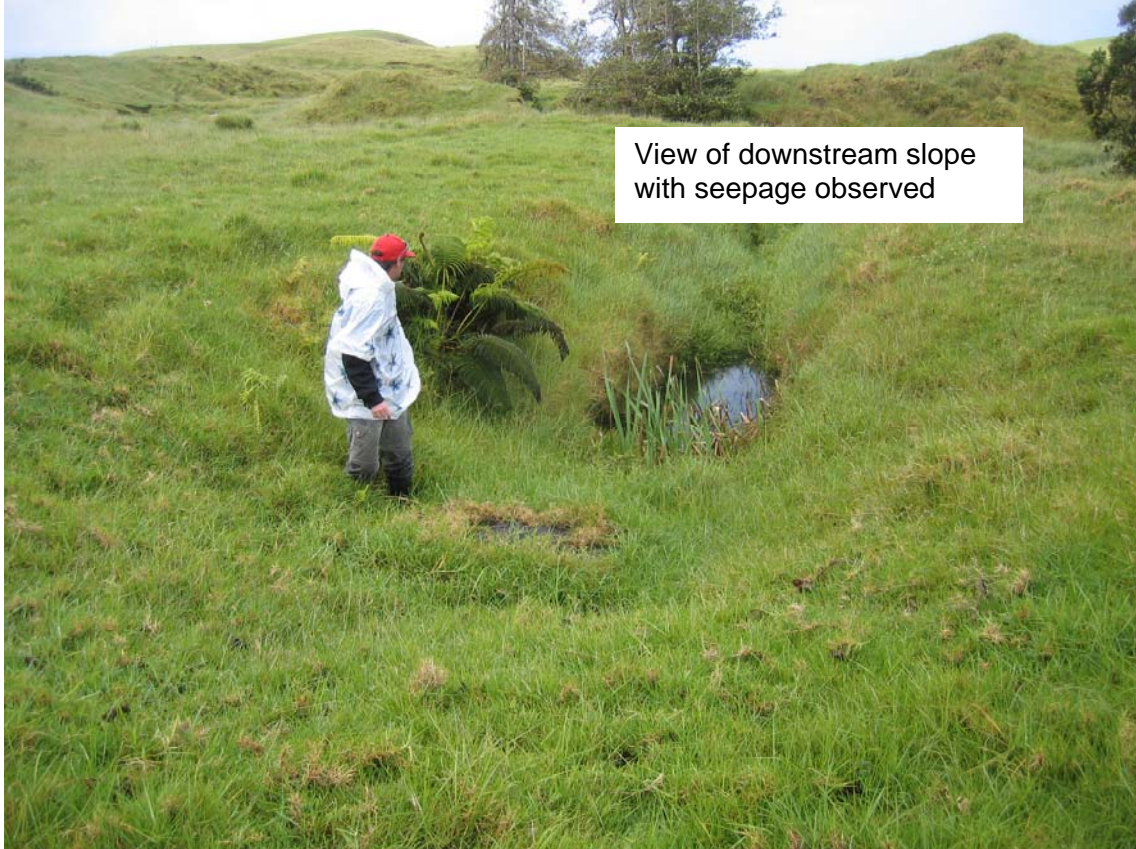
View of downstream slope  
with seepage observed

Seepage: Seep Spot Number 1  
☒ Green Vegetation ☒ Wet or Muddy Ground ☒ Ponding Water ☐ Not Visible ☐ None Observed  
☒ Flowing, Description: Due to wet conditions flow was difficult to detect.  
Water Clarity: ☒ Clear ☐ Some particles ☐ Muddy ☒ Other: Iron stained  
Description: Seep begins on east side of reservoir and flows or is wet to the south portion

**No immediate threat observed for the dam or reservoir at the time of inspection. Recommend regular monitoring even installing devices to monitor quantity and clarity of seepage water.**

- ☒ h. Seepage/Ponding water was observed. Monitor and conduct further investigation to locate the source of water and extent of any possible hazardous or developing condition.
